Notes before Continuing

Toyota LC200 VX/Sahara 2016-2021 (<u>https://aerpro.com/AMUTO53</u>) Navigate to the Aerpro website (<u>https://aerpro.com</u>) and search for your head units model number based on the system version your head unit lists.

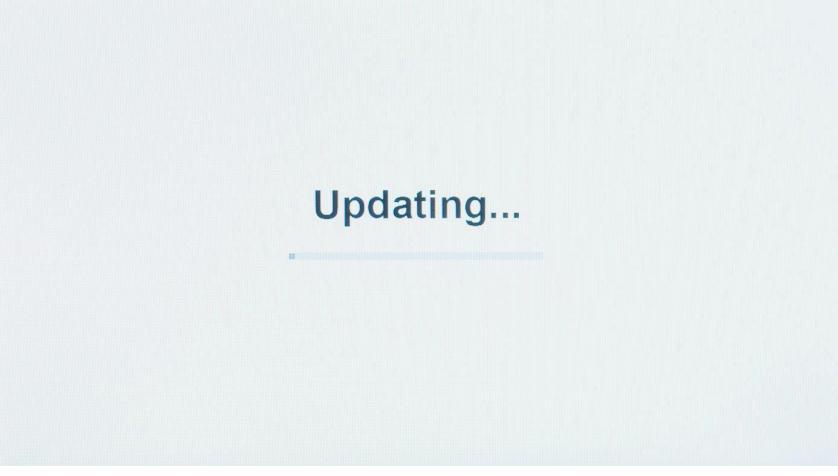
Once you have confirmed the update, the system may reset a couple of times and show a black screen in between. **DO NOT TURN OFF THE VEHICLE DURING THIS PROCEDURE.** Please be patient with the process. An update screen will appear. Continue waiting and you will get a screen that looks similar to below.

The home screen may appear during the update process, but **continue to wait until a progress bar appears with a black screen**.

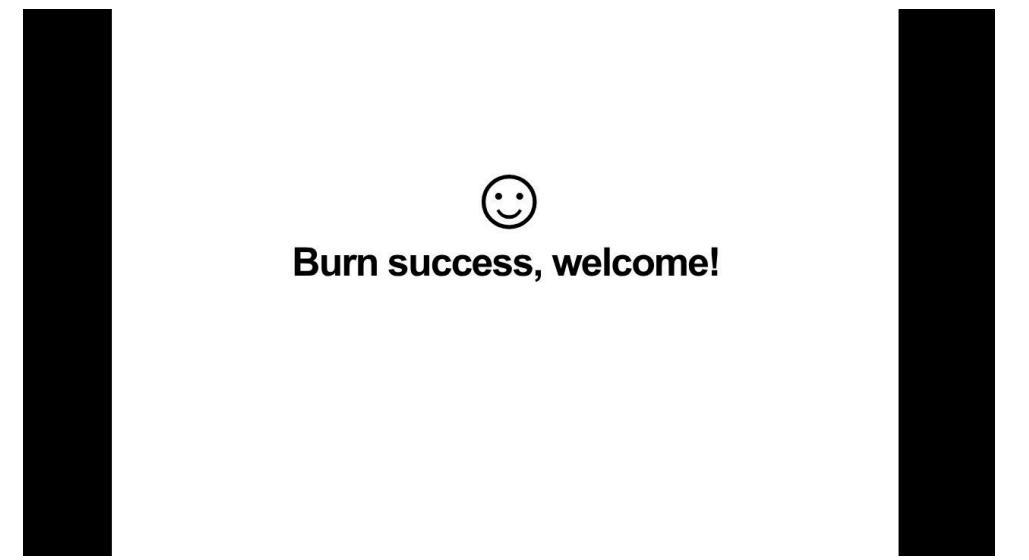
When the update is finished you will see the below message which means the update has been completed.

Please Remove the USB drive and restart the vehicle when this screen appears.

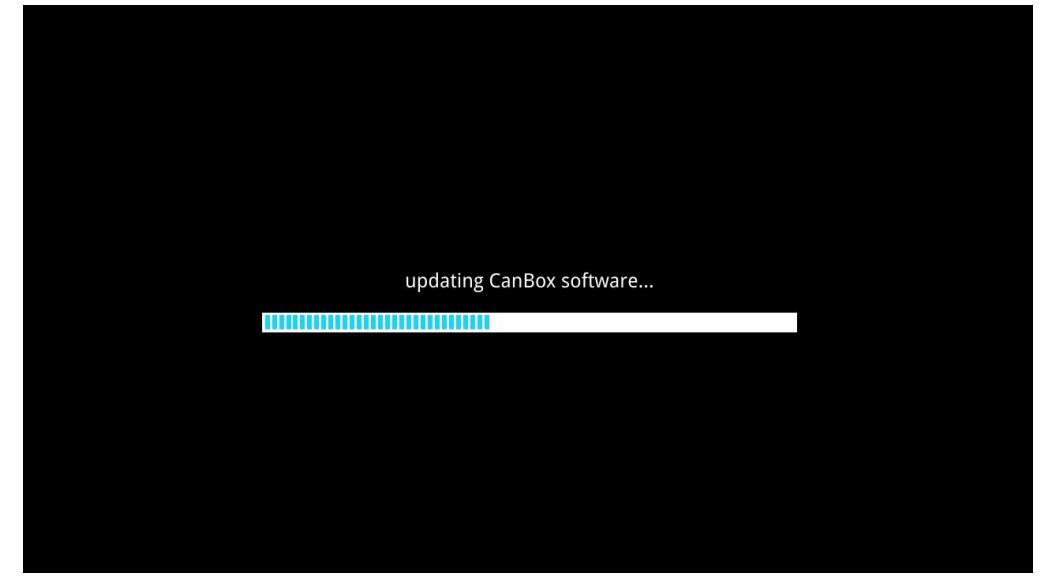
The unit will then reboot. Please do not touch anything while this process is happening. The head unit will automatically show the following screen with a progress bar like the image below. NOTE: It may reboot a couple of times during this process. Please wait until it finished and asks to remove the USB

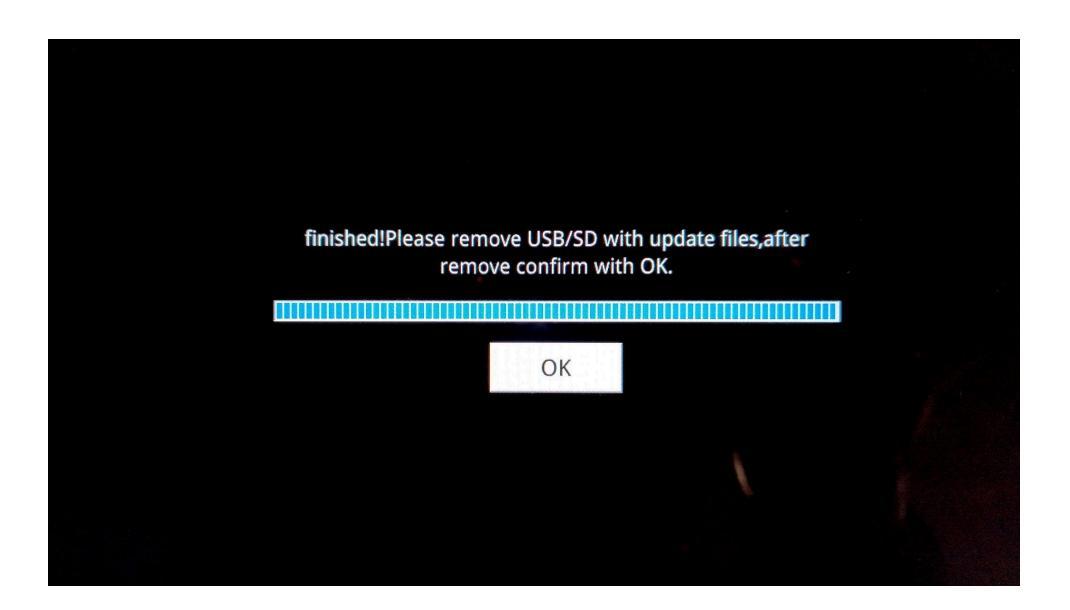
Please be patient with the process. Continue waiting and once the progress bar finishes you will get a screen that looks similar to below.

You will then be asked to **remove the USB BEFORE pressing the OK button** as the image above. Once the USB is taken out, you can continue by pressing the OK button on the screen. Pressing it once is sufficient, it will eventually restart. The update is now complete.
